Garmisch positive dip update, Ralf Sussmann and Markus Rettinger

Cause for positive (Garmisch) dip?

Hypothesis: The (bad?) detector inserted on 13 Dec 2007 caused the dip

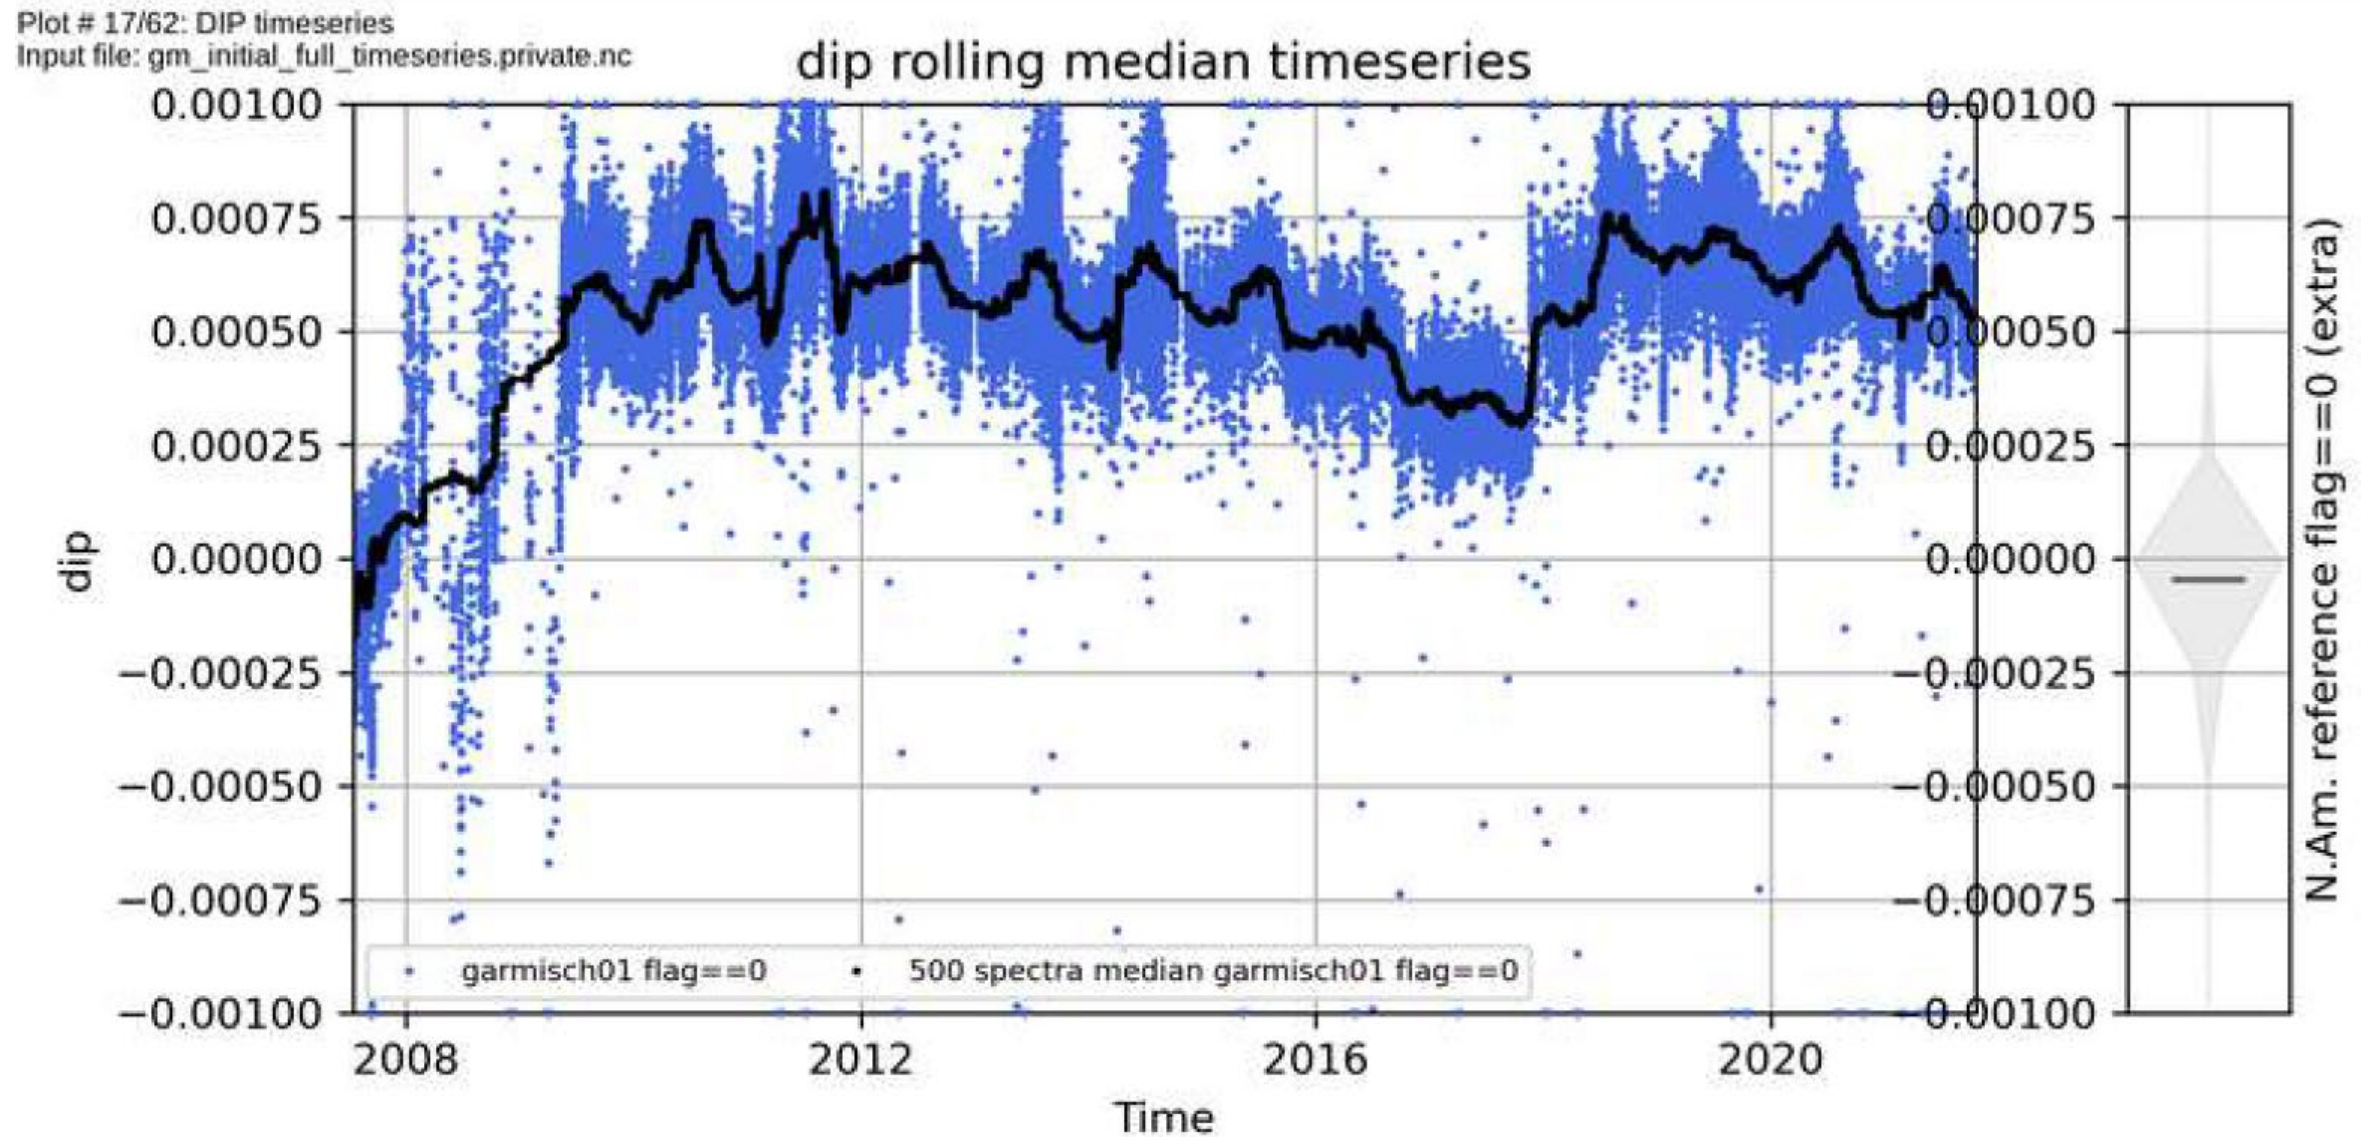
Garmisch dip levels [+0.0005; +0.00075] had been the highest positive ones in the network

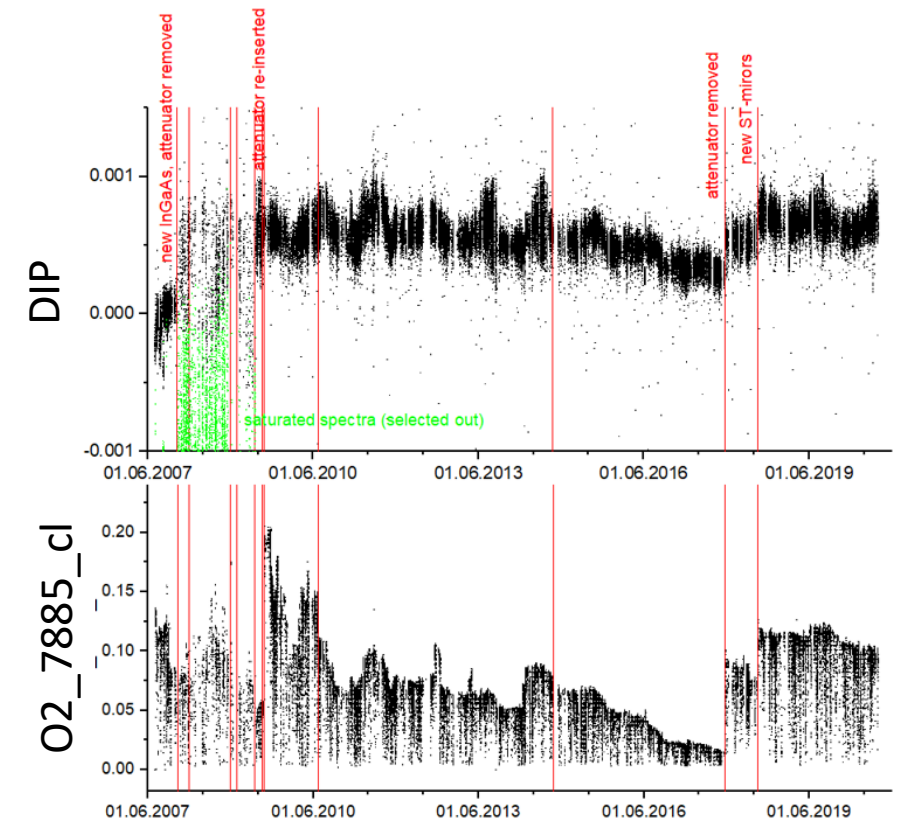
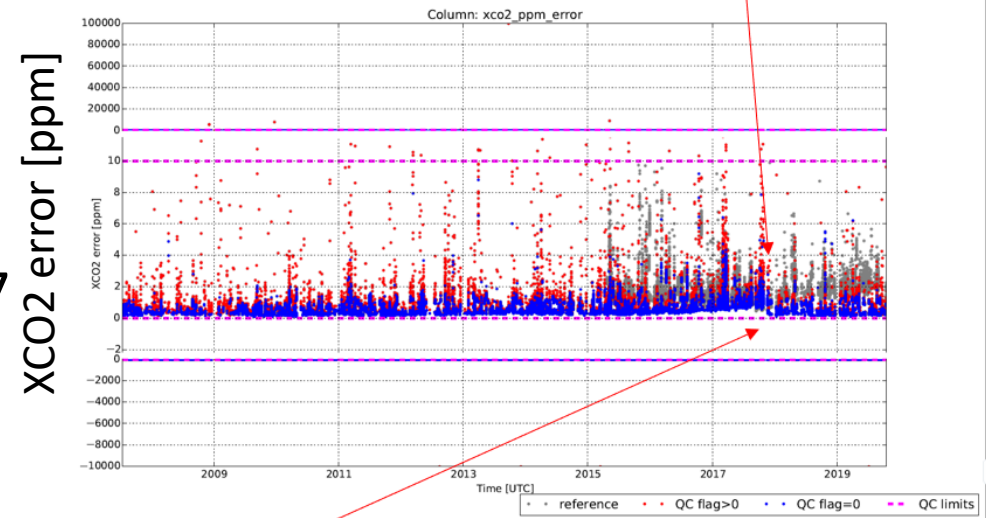
- The **down jump** in XCO2 error is coincident with increasing photon intensity by 3.6 (removing the attenuator).

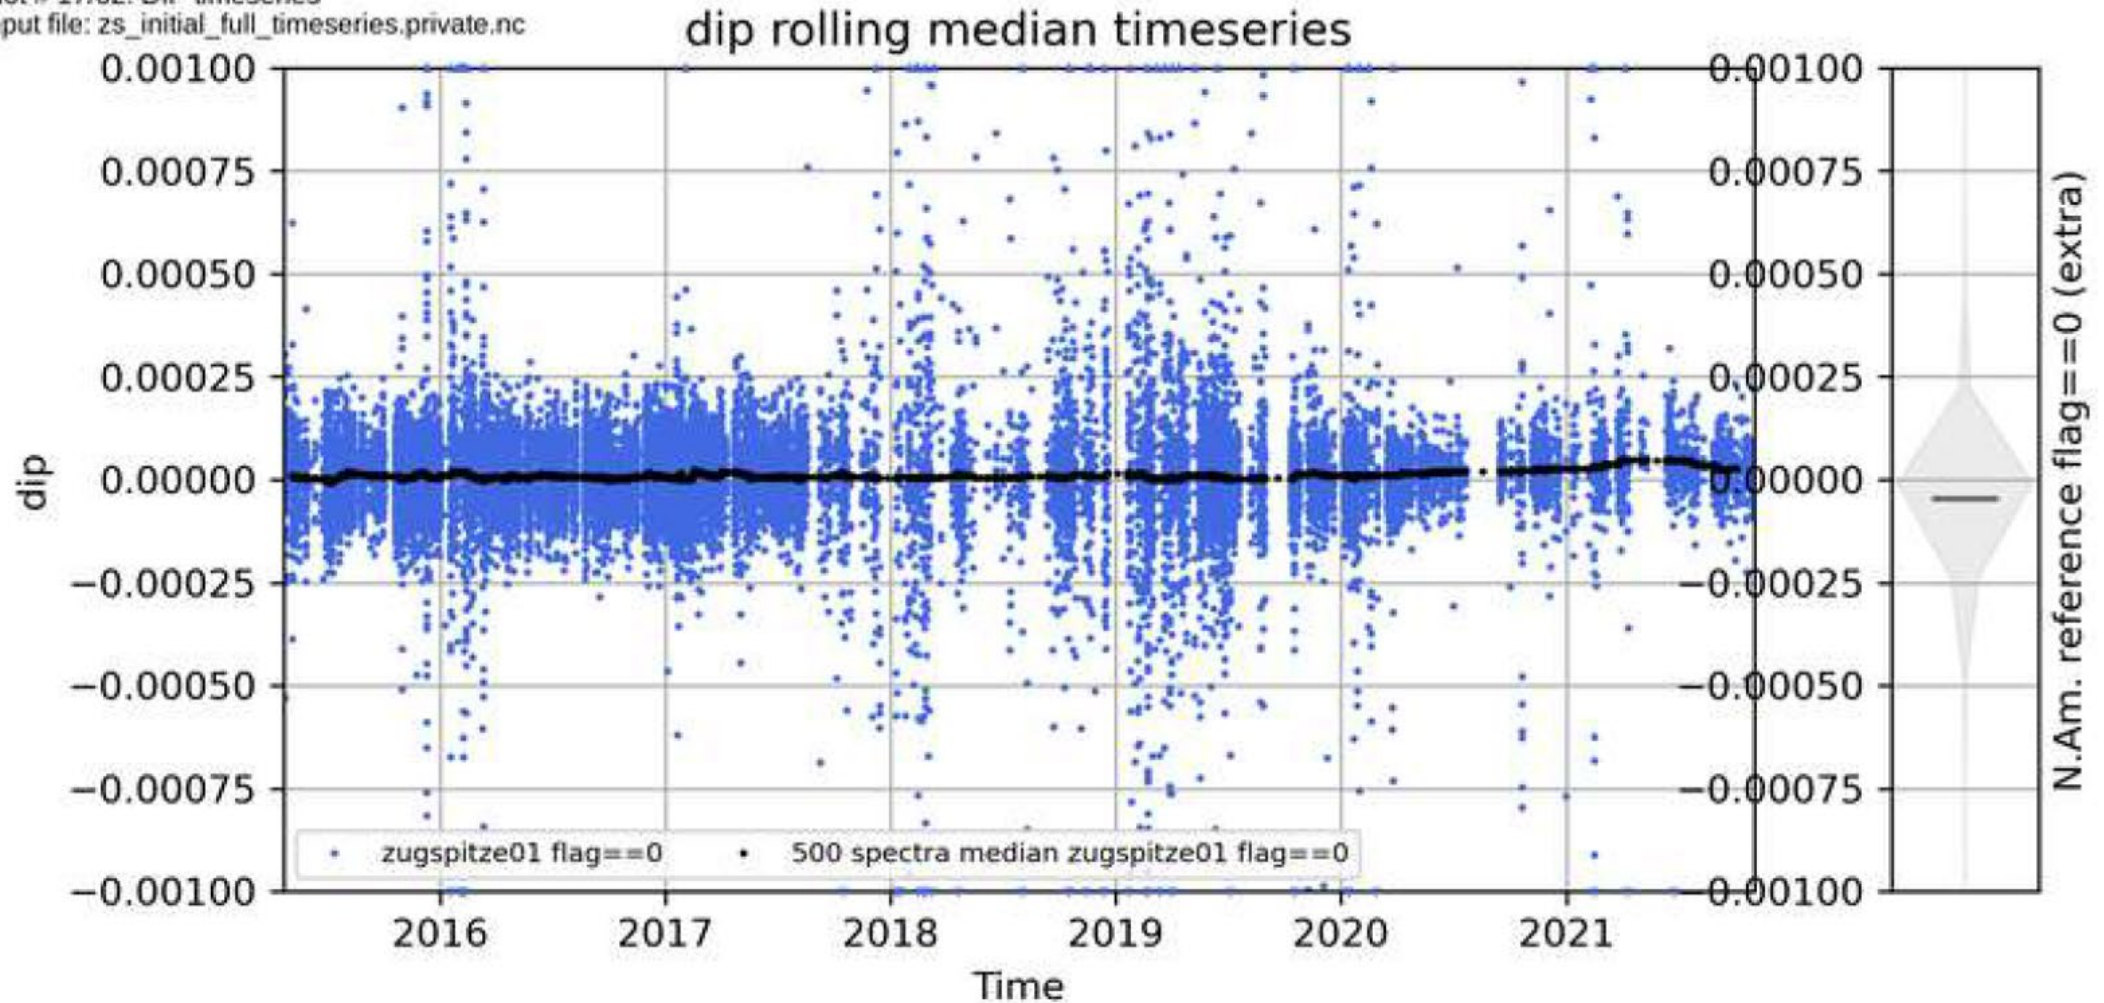
Plot # 17/62: DIP timeseries
Input file: zs_initial_full_timeseries.private.nc

Zugspitze DIP timeseries: DIP [0; 0.00008]

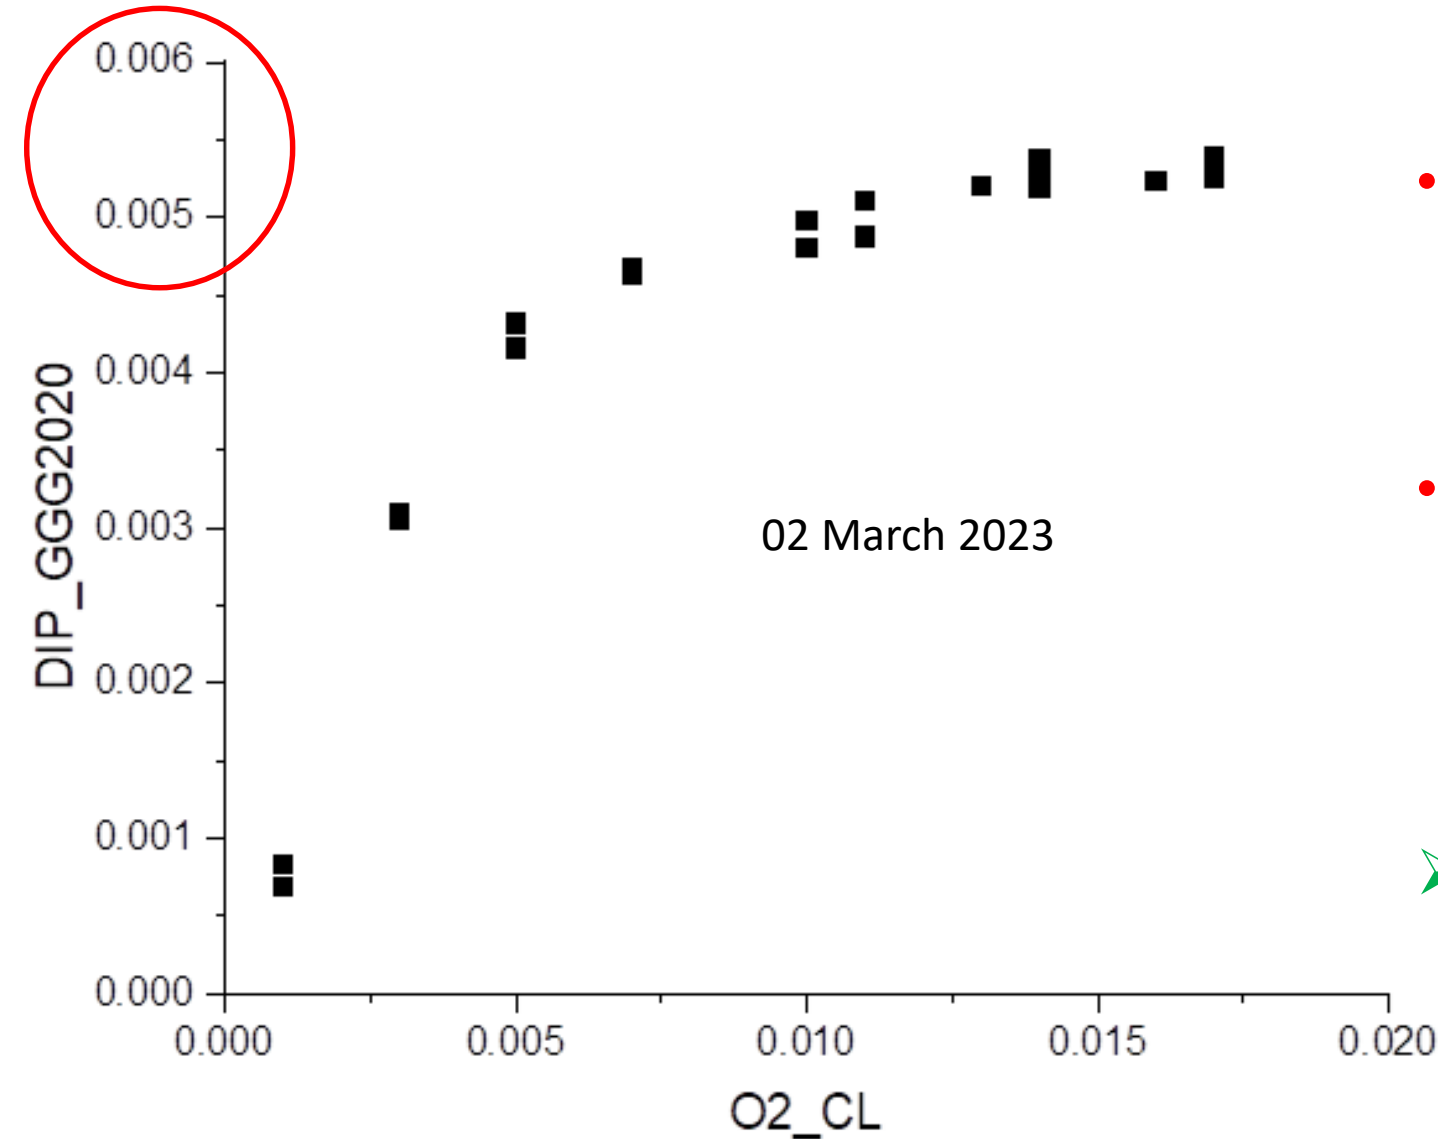
Solar measurements with Zugspitze InGaAs @ Garmisch FTS: **Unsuccessful 1st attempt**

- Dip not smaller with Zugspitze InGaAs as expected (0.00008), but indeed a factor 10 higher than with Garmisch InGaAs
- Possible cause: We had not realigned the focusing mirror before the detector after detector swapping
- Redo the experiment: realignment of focusing mirror allowed to increase peak amplitude 9000 -> 27000, with the following result:

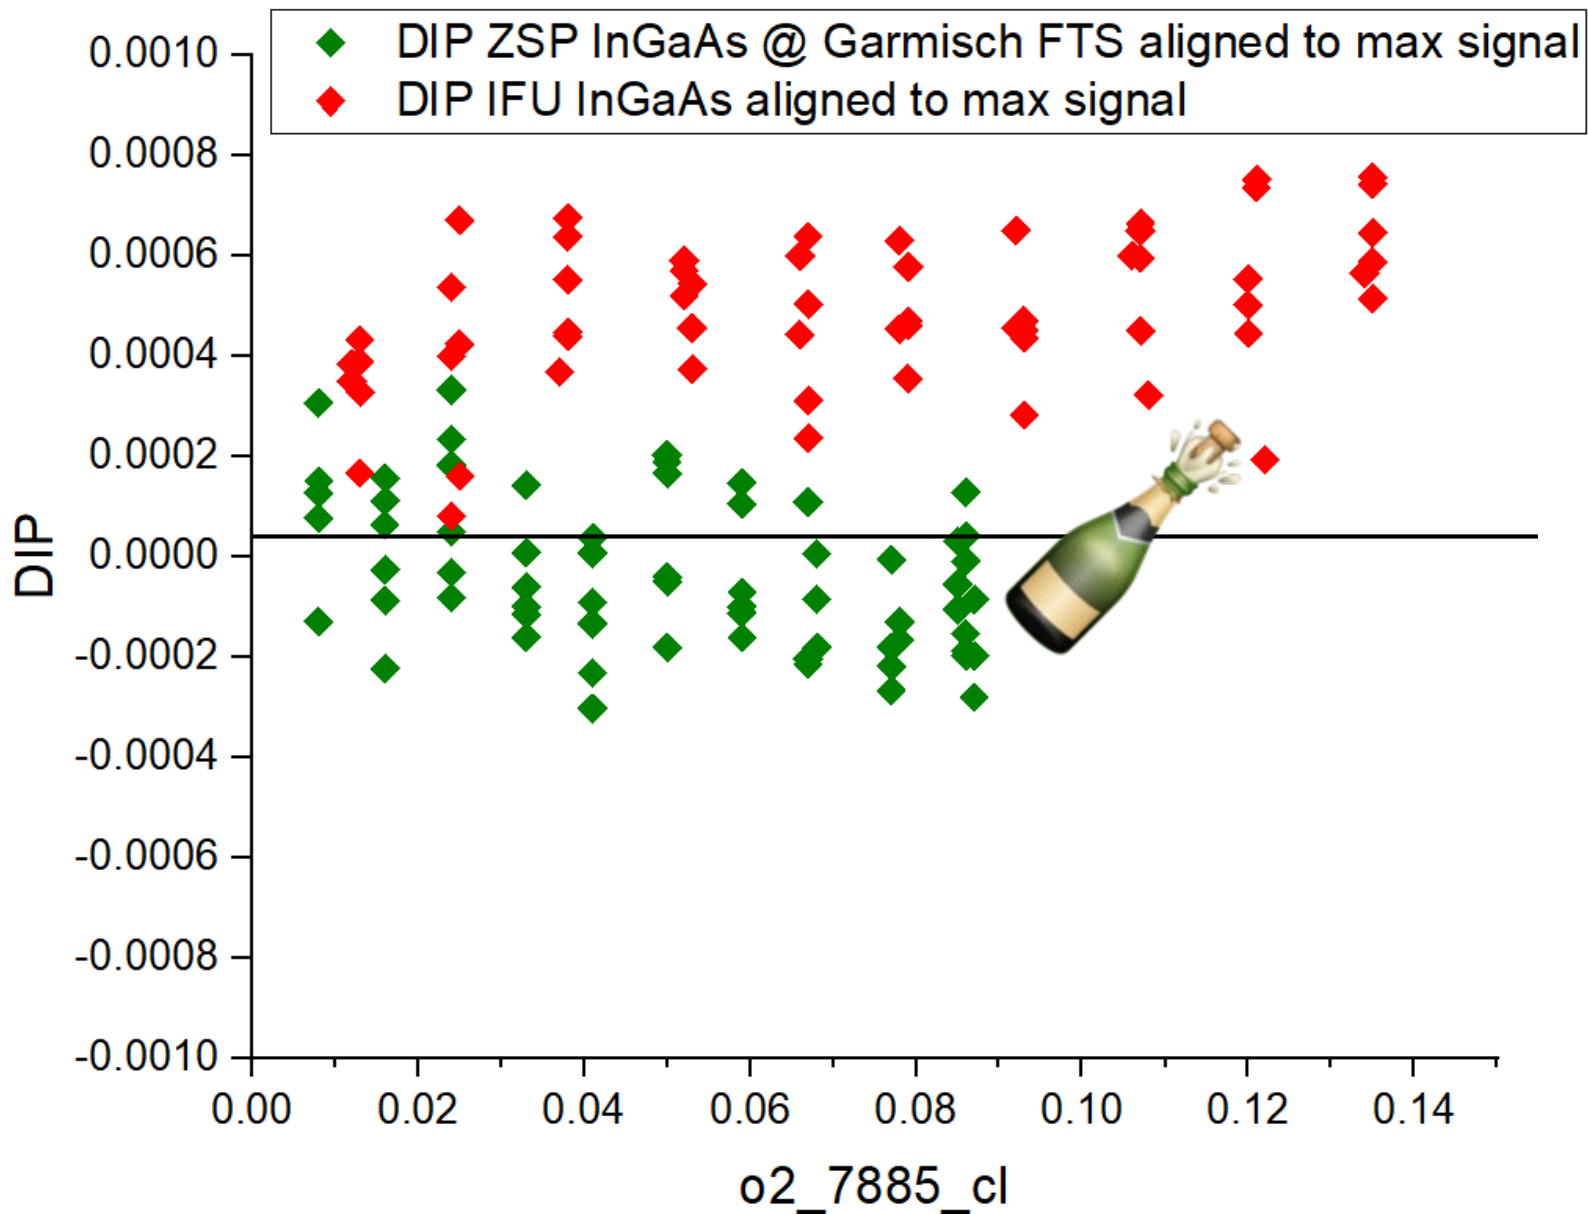
Solar measurements with Zugspitze InGaAs @ Garmisch FTS:

Success after realignment of focusing mirror

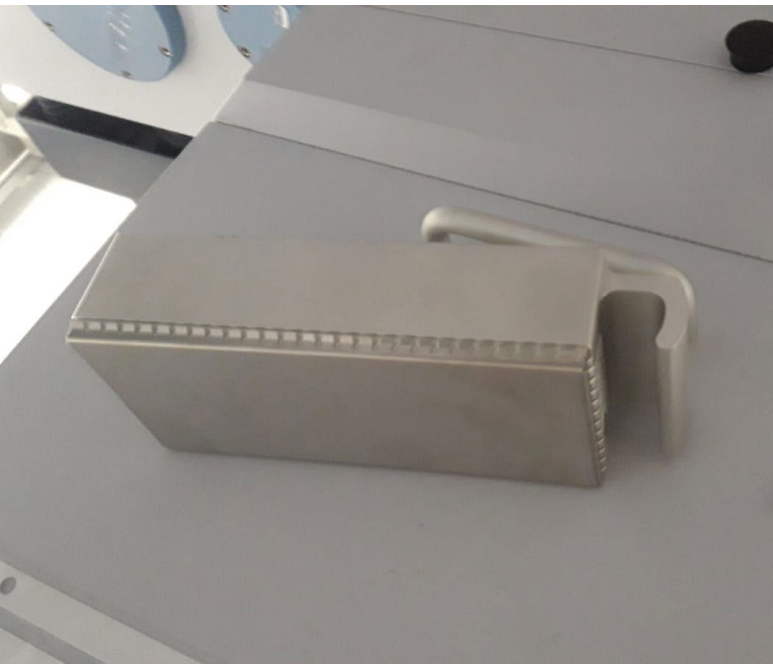
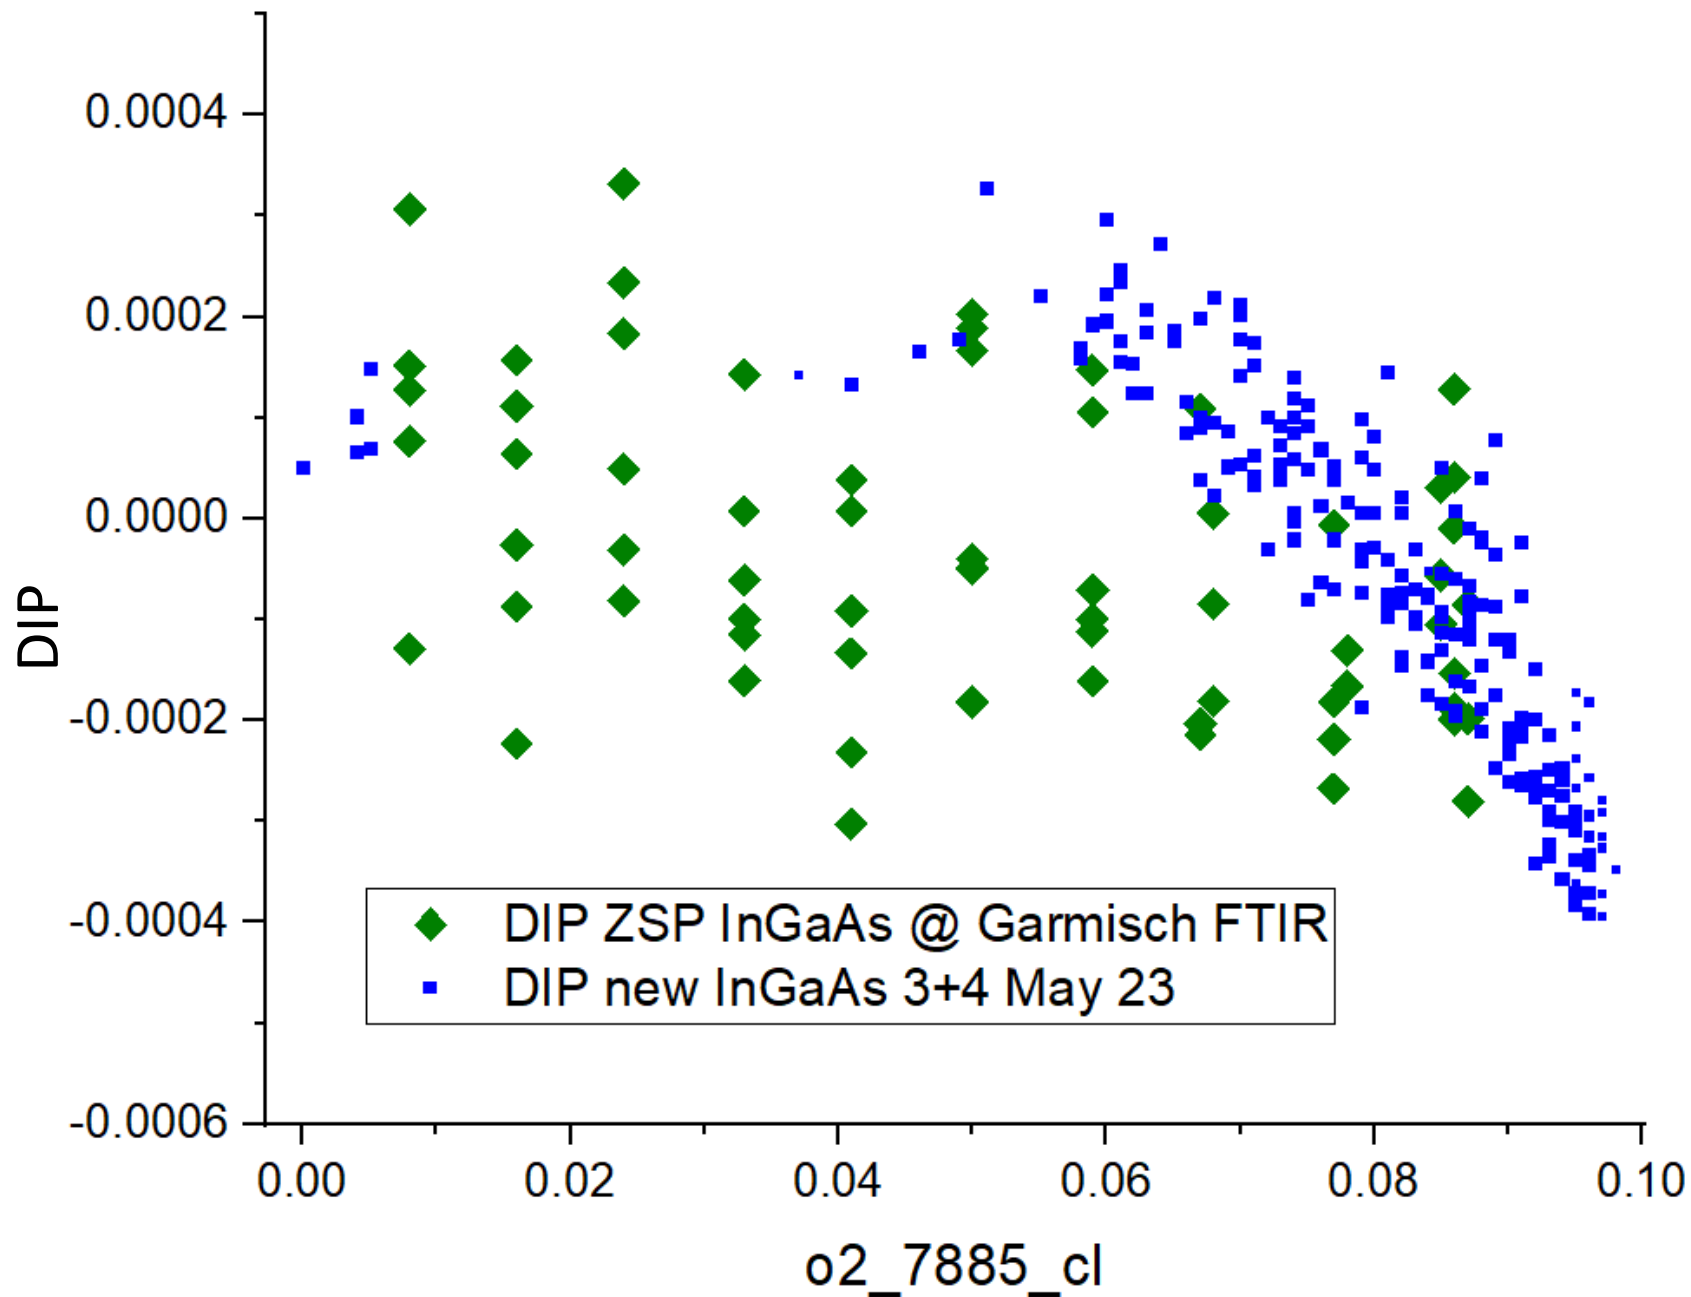
Ordered a **new InGaAs** for the Garmisch FTS: **Also no positive dip but differing O2-cl sensitivity**
